Hot Corrosion of Single-Crystal NiAl-X Alloys

James A. Nesbitt
Lewis Research Center, Cleveland, Ohio

National Aeronautics and
Space Administration

May 1998

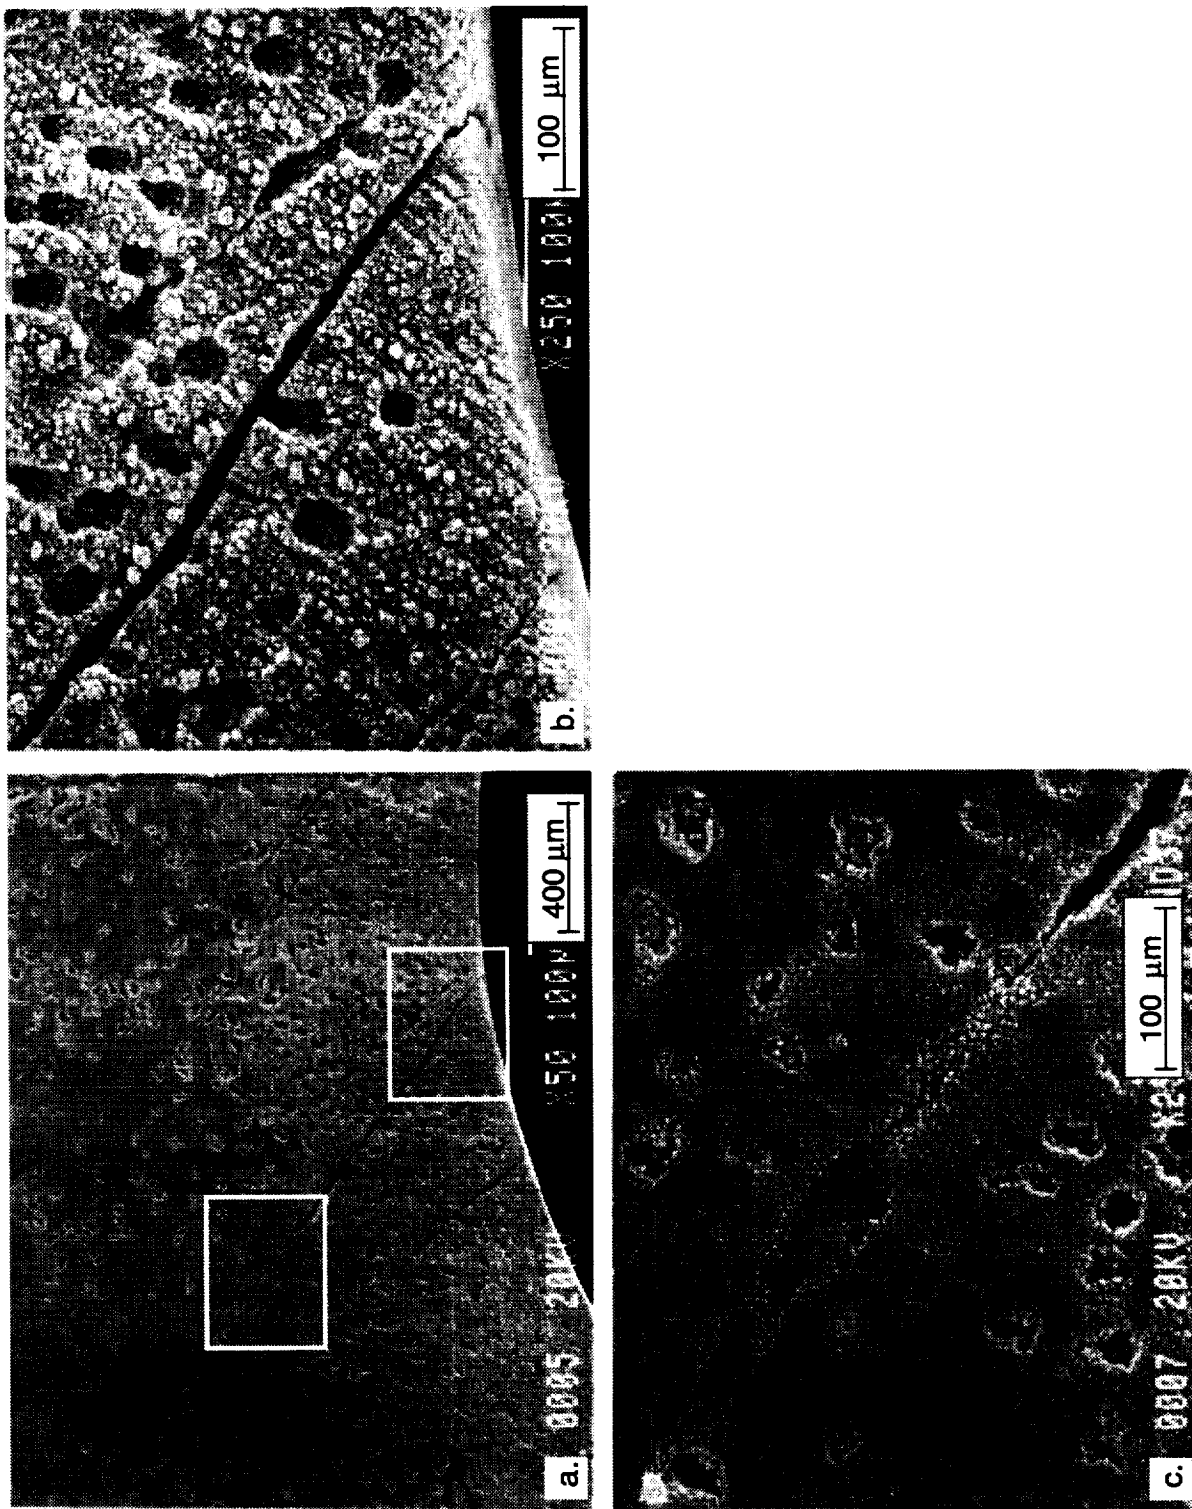
Fig. 44 SEM micrographs of end 2 near the ID edge of AFN19 after 300 cycles, (b) and (c) are magnified views of (a) and (b).

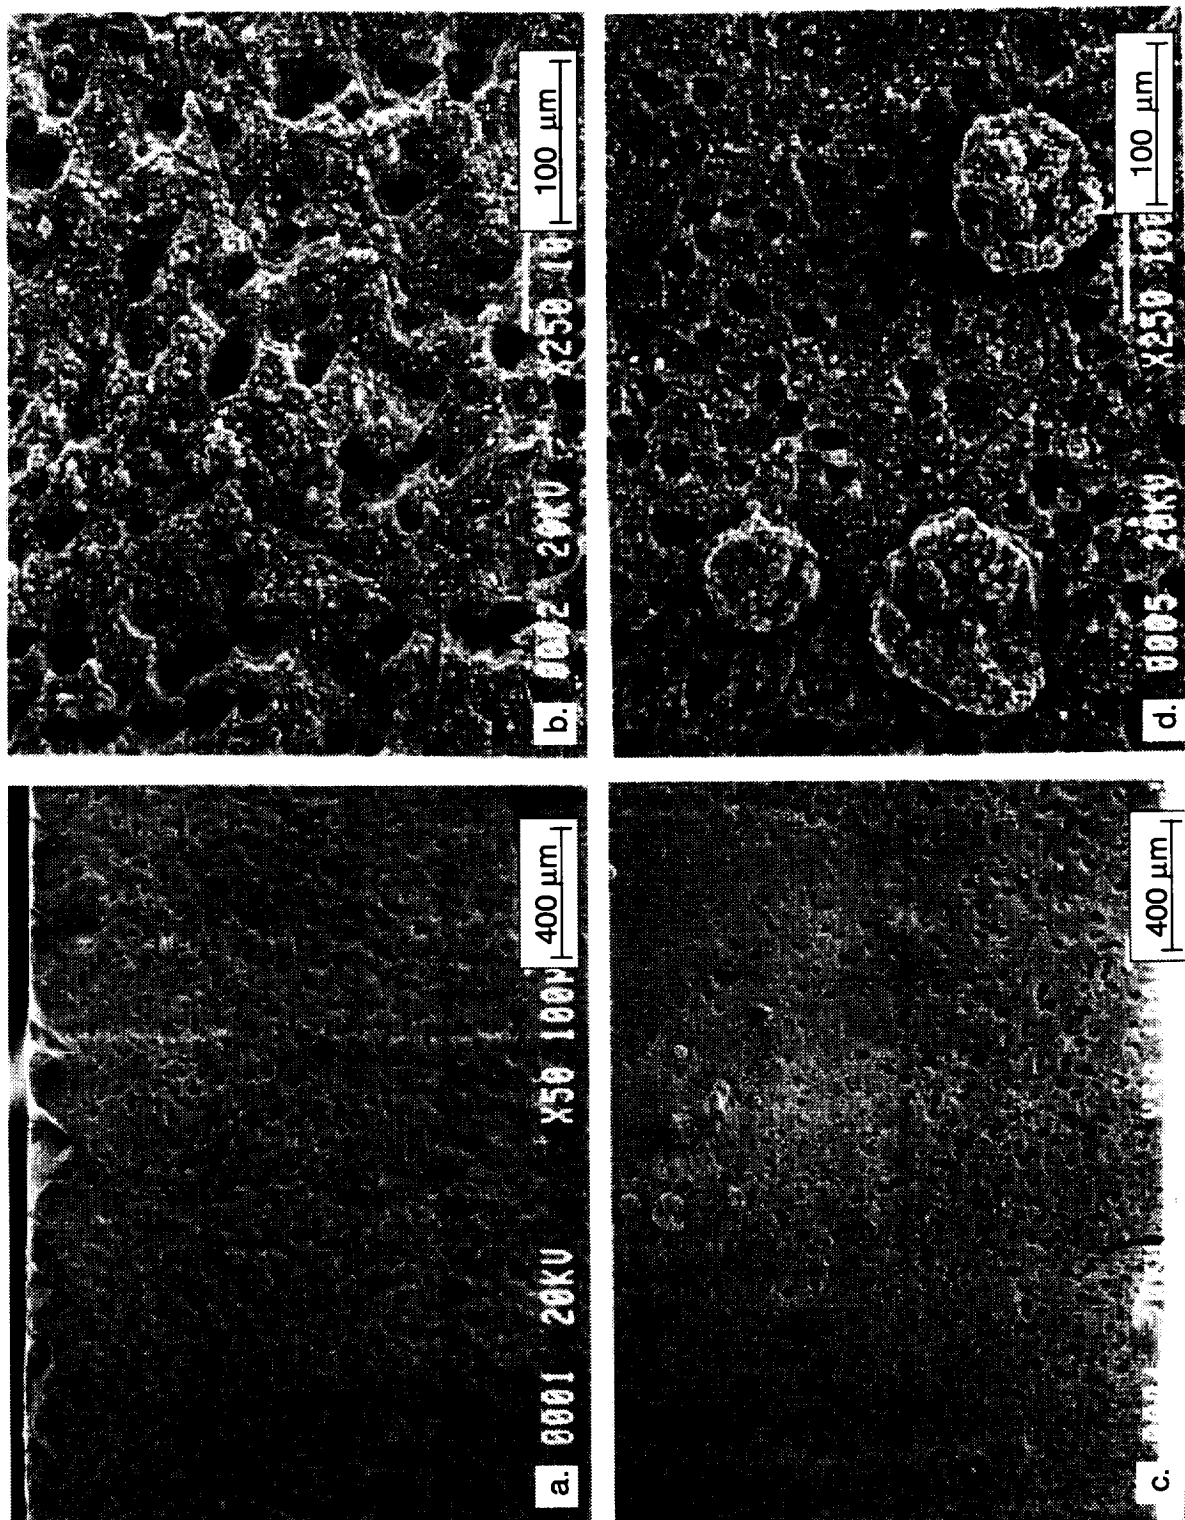
Fig. 45 SEM micrographs of the curved surfaces near each end of AFN19 after 300 cycles, (b) and (d) are magnified views of (a) and (c). The large particles in (d) are rich in Fe and Ca.

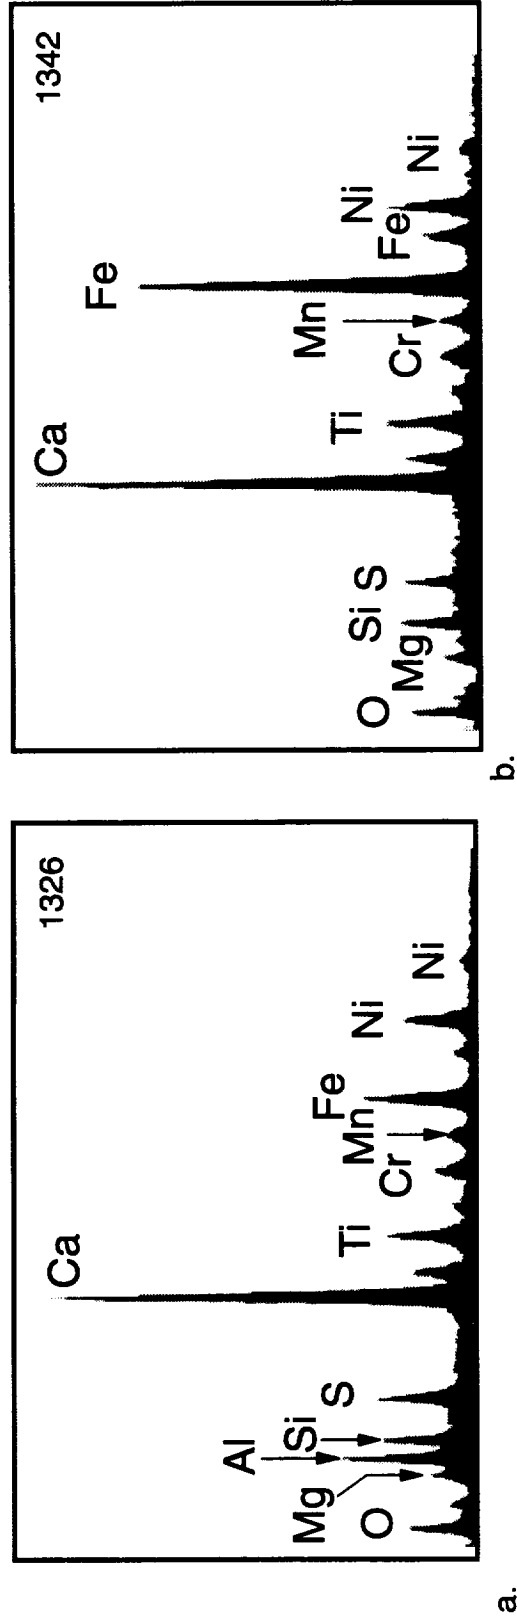
Fig. 46 EDS spectra of (a) the porous regions shown in Fig. 45a,b, and (b) the large particles in (d).

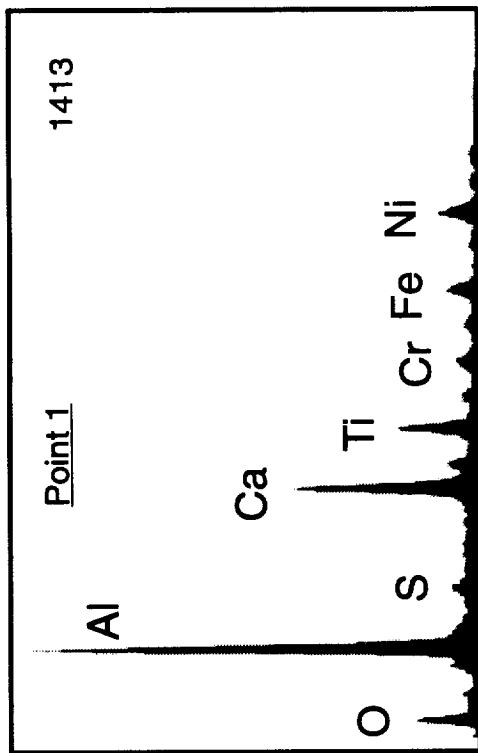
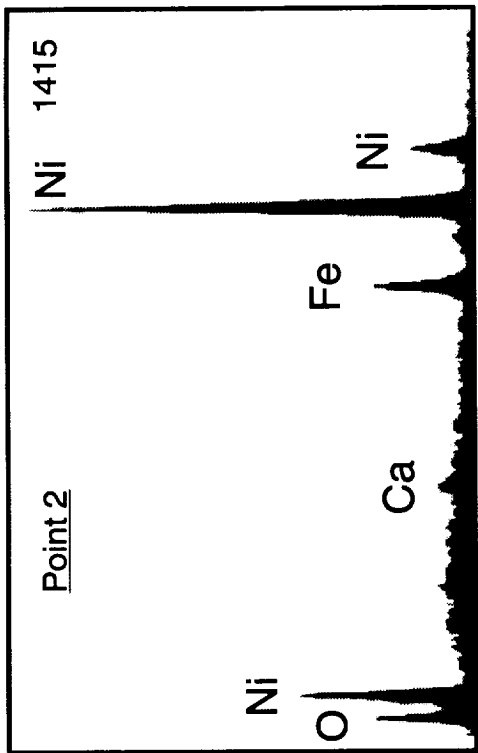
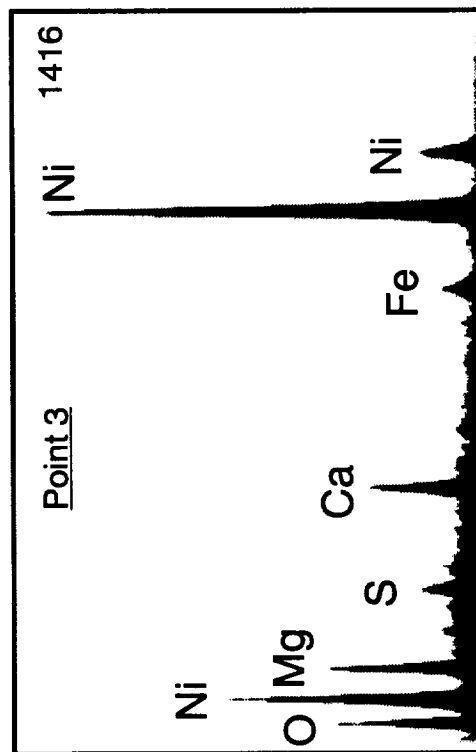
Fig. 48 EDS spectra of points (1), (2) and (3) in Fig. 47c.

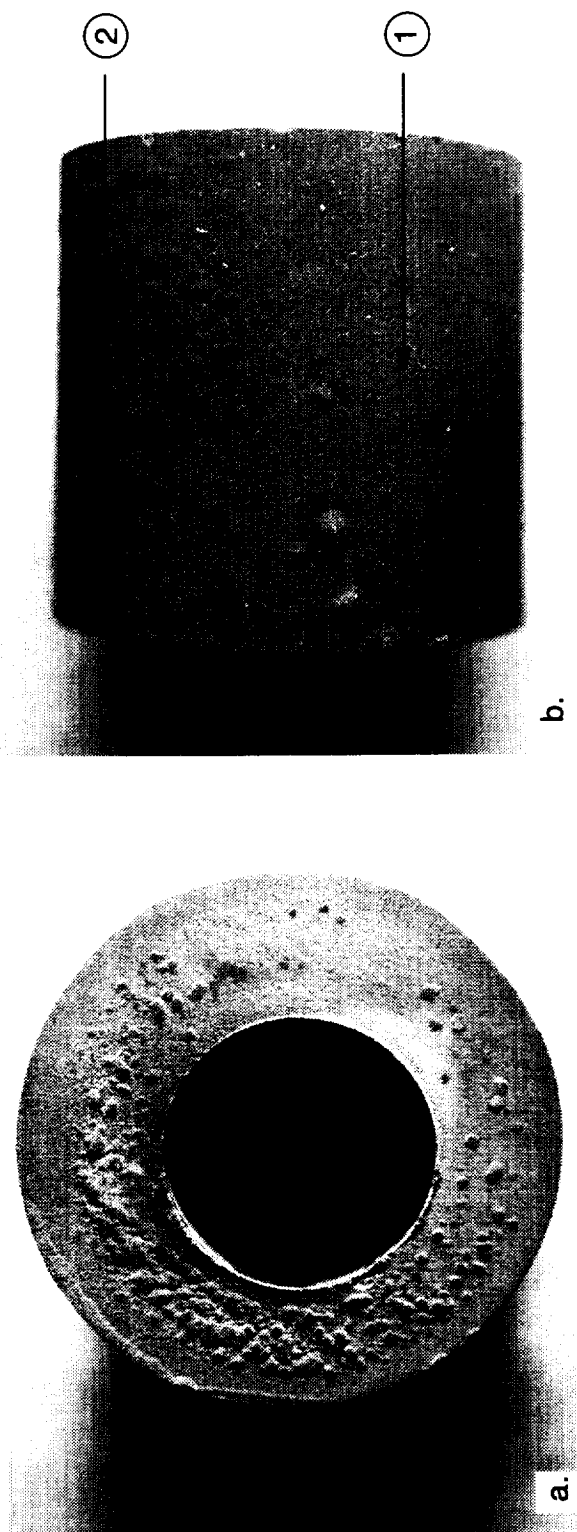
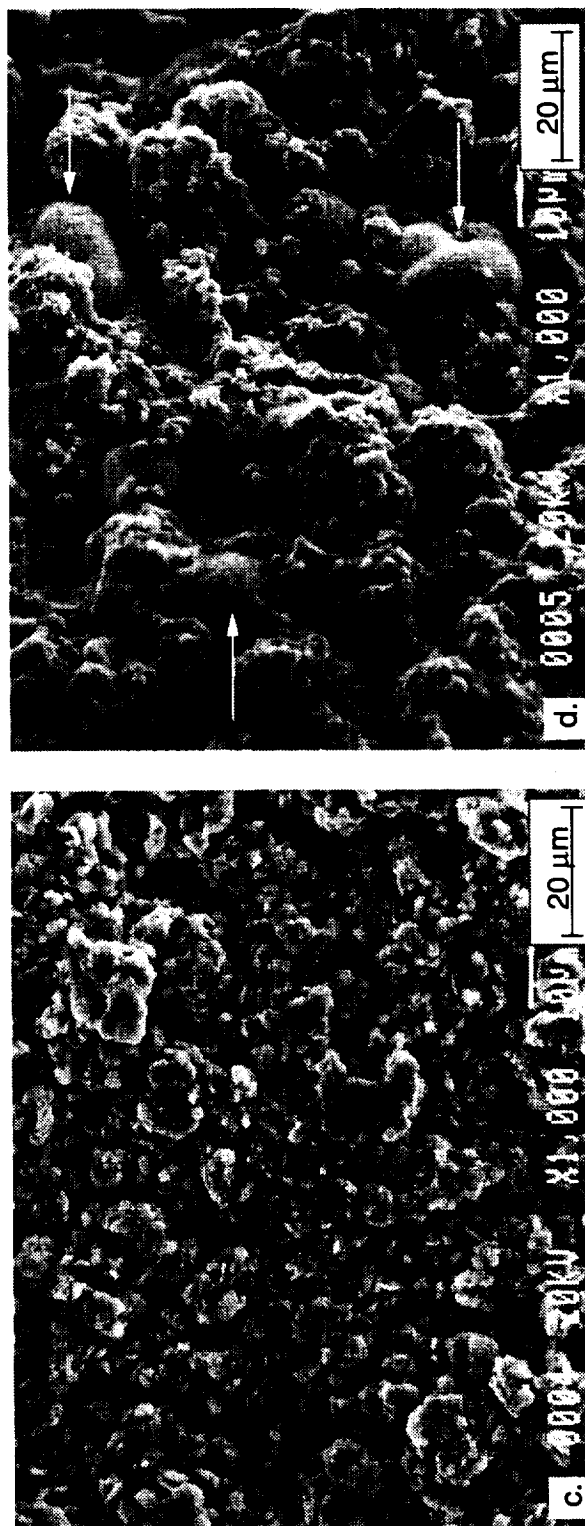
Fig. 49 Optical (a,b) and SEM micrographs of AFN23 after 300 cycles showing the (c) smooth scale in region indicated "1" and (d) rough scale in region indicated "2" with arrows indicating NiO.

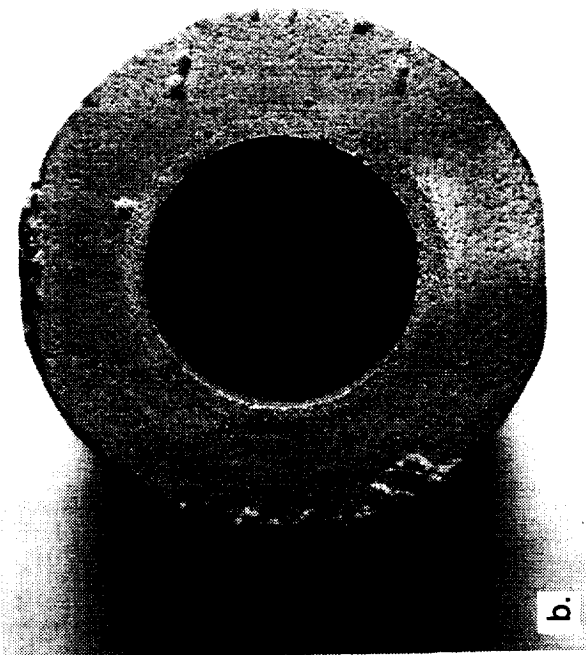
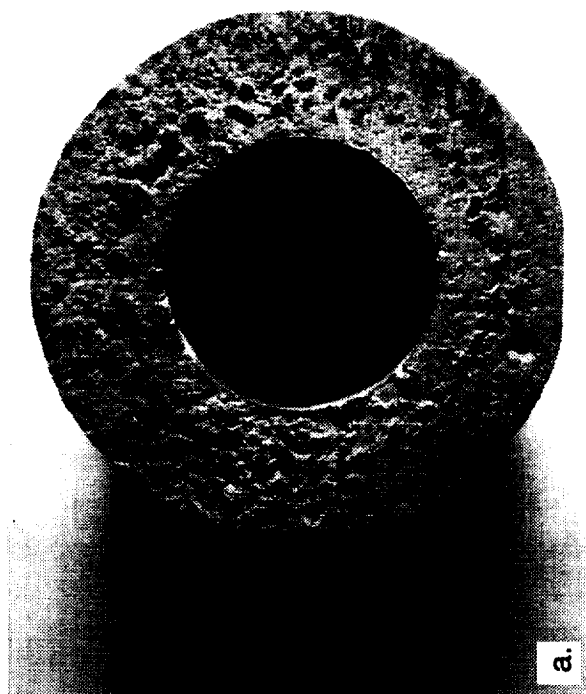
Fig. 50 Optical macrographs of the ends and curved surface of AFN24 after 300 cycles.

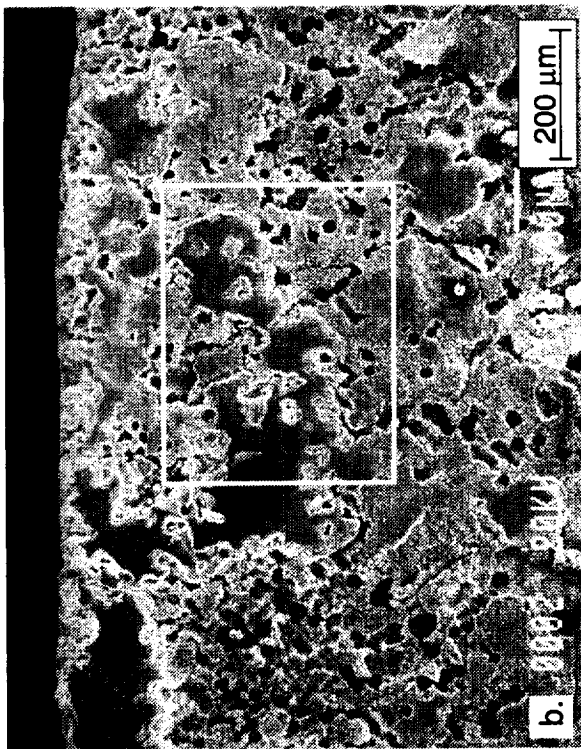
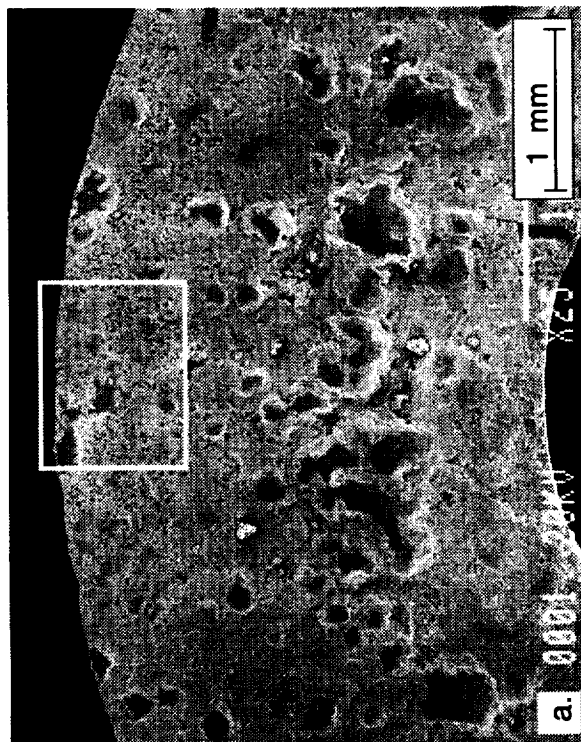
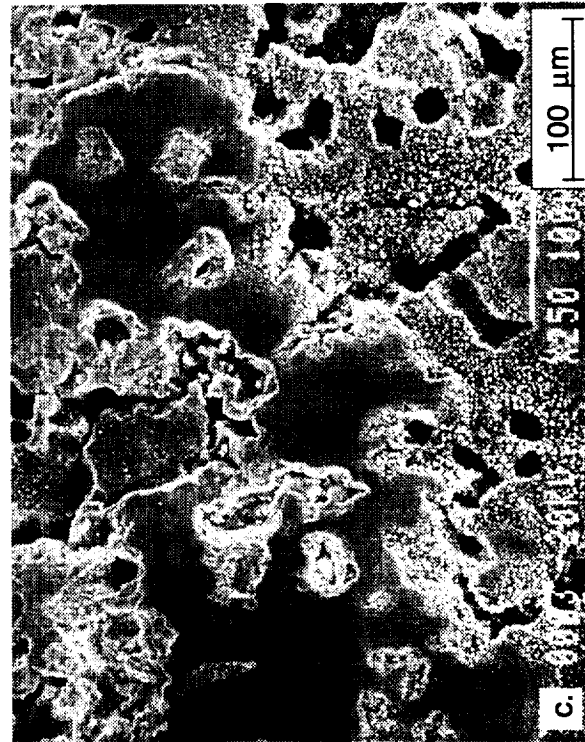
Fig. 51 SEM micrographs of the end of AFN24 after 300 cycles, (b) and (c) are magnified views of (a) and (b), respectively.

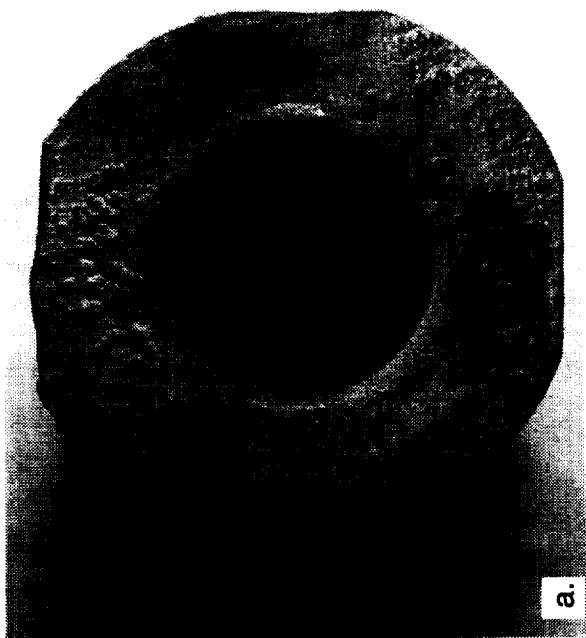
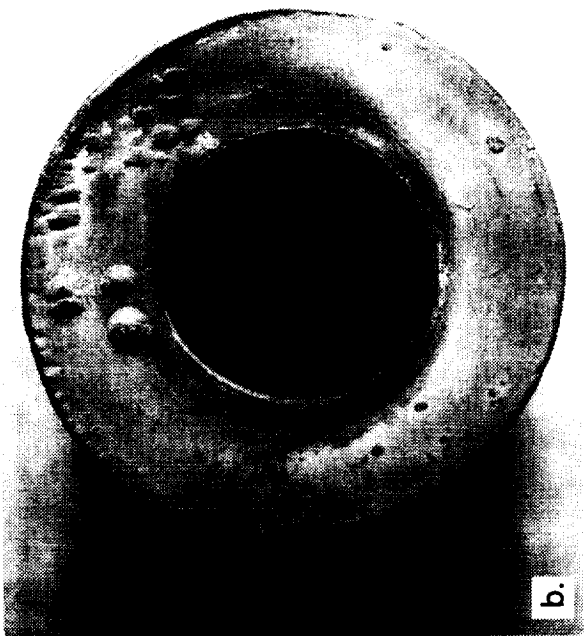
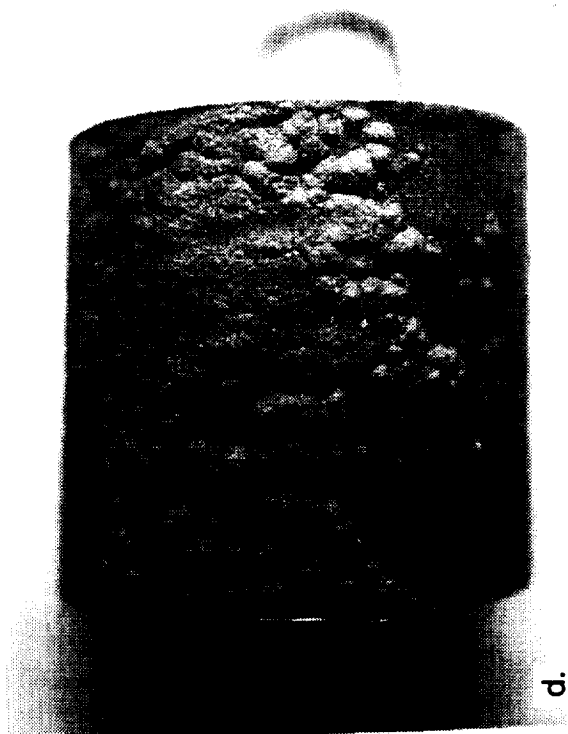
Fig. 52 Macro photographs of the same AFN25 sample as shown in Fig. 11 after 200 hrs of testing. The arrow in (c) shows the same irregular region on the curved surface as in Fig. 11b.

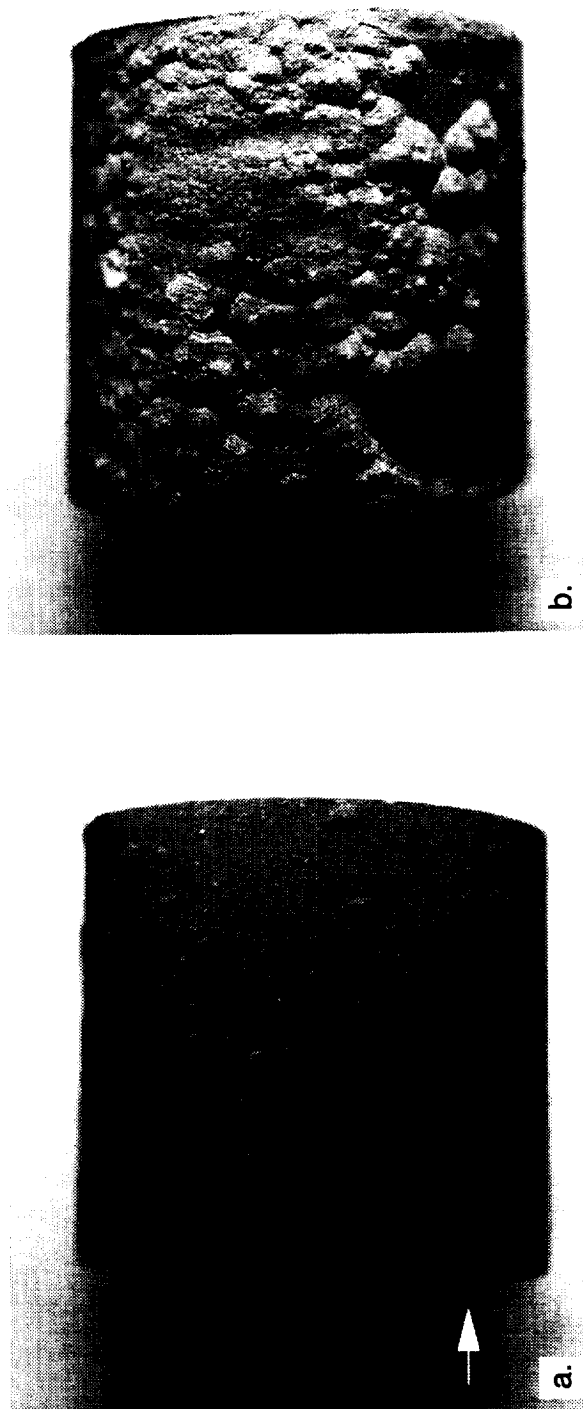
any indication of increased hot corrosion attack after 300 hrs (see arrow in Fig 53a). However, one of the other irregular surfaces on the curved surface of AFN25 which exhibited the typical flat matte finish after chemical milling, did undergo severe hot corrosion attack (Fig 53b). Hence, the different responses of a surface to the chemical milling treatment do not necessarily indicate the hot corrosion resistance. It again appears most likely that chemical inhomogeneities within the sample may be the cause for the widely different hot corrosion response on the same sample. Widely different responses to hot corrosion on the same sample was observed with numerous alloys (AFN20, Fig 59, Fig 82; D219A, Fig 68; AFN26, Fig 77d,e; to a lesser extent on D219B, Fig 69). Compositional inhomogeneities in AFN23 tested in Series II appears the only reasonable explanation for the anomalous behavior of this alloy which exhibited a higher weight gain in Series II than in Series III. The scale morphology of this alloy did show a localized accelerated attack on part of the curved surface during Series II testing.

Fig. 53 Macrophotographs of AFN25 sample after 300 hrs. The arrow in (a) shows the same irregular region as in Fig. 52c and Fig. 11b.

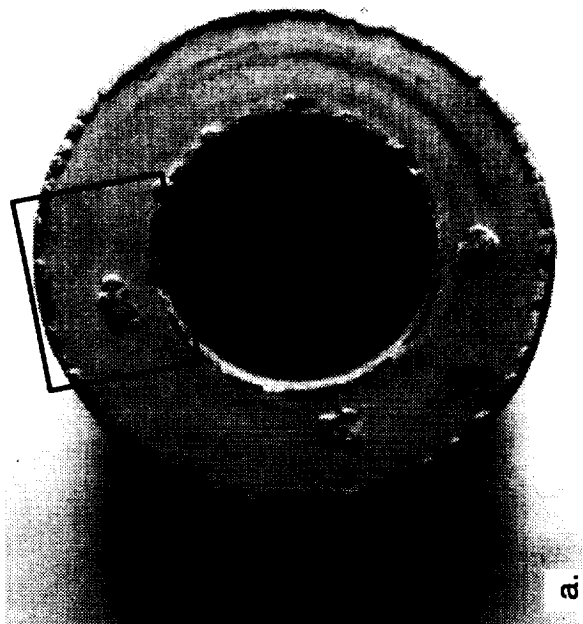
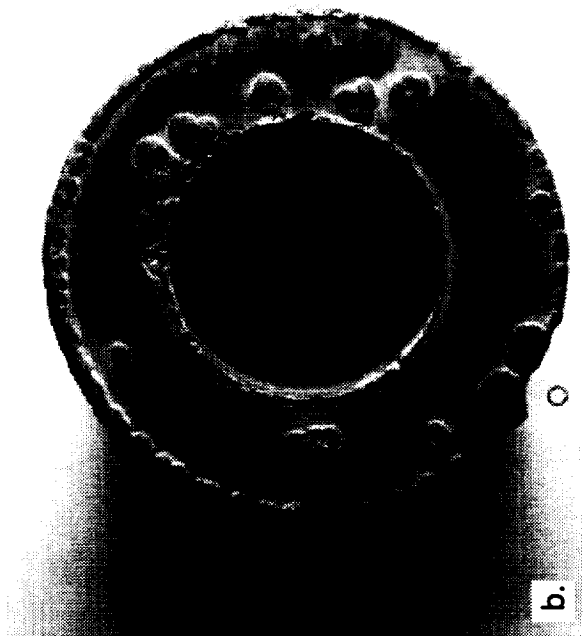
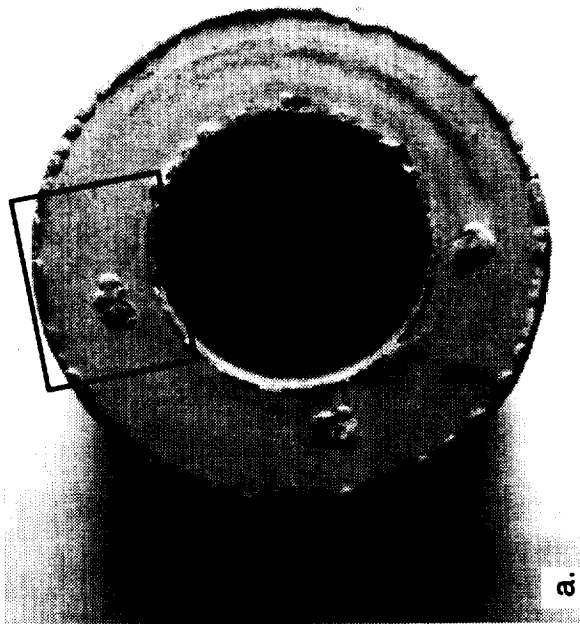
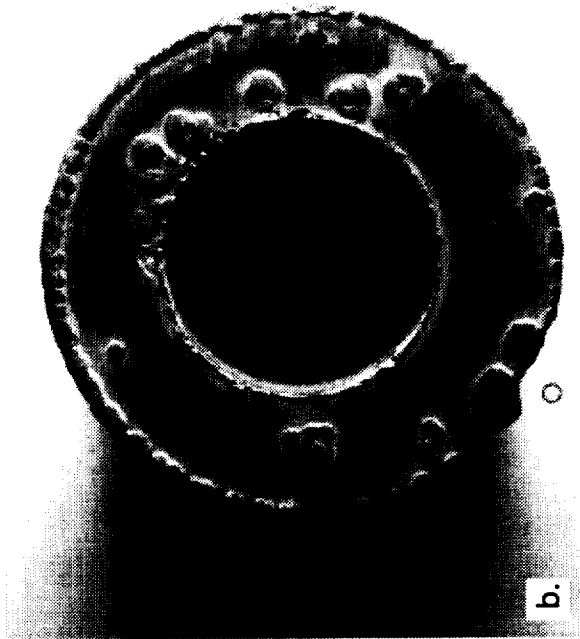
The D218 alloy exhibited a minimal amount of hot corrosion attack on the surface and a low weight gain similar to that of AFN19. The limited number of corrosion mounds on the ends and curved surface are shown in Fig 54. The chip missing from the edge of the sample in Fig 54c is the cause of the weight decrease between 60 and 70 hrs shown in Fig 35. The only peculiar surface morphology change with this sample was the disproportionate attack at the ID and OD edges which resulted in the formation of a corrosion product "lip" (Fig 54a,b). A magnified view of the end of the sample and the "smooth" oxide in the center of the end is shown in Fig 55. The EDS spectra of this scale is nearly identical to that shown in Fig 46a only with a slightly higher Al peak suggesting this smooth scale is $\text{Ca}_3\text{Al}_2\text{O}_6$. The corrosion mound and part of the lip shown in the box in Fig 55a is shown at higher magnifications in Fig 56. The backscattered electron (BSE) image in Fig 56c clearly shows the cracks near the edge resulting from the growth of the lip as well as bright regions associated with oxides formed with high atomic number elements. The smooth, darker oxides in Fig 56b (point 1 in Fig 56c) are Al-rich with smaller concentrations of Ca and Ni, such as that shown in Fig 42d, and likely contain Al_2O_3 , possibly mixed with some NiAl_2O_4 and $\text{Ca}_3\text{Al}_2\text{O}_6$. The bright oxides in Fig 56c (point 2) are Ni-rich, most likely NiO , with some locations containing small concentrations of Al, Cr and Ca. The top of the mound (point 3) again contains comparable amounts of Al and Ni, similar to the EDS spectra shown in Fig 41c suggesting the oxide is primarily NiAl_2O_4 . The bumpy nodules (point 4) in the figure are again Ca and Al-rich, with nearly equal peak heights.

Fig. 54 Optical macrographs of D218 after 300 cycles. Box in (a) shows area of view in Fig. 55a.

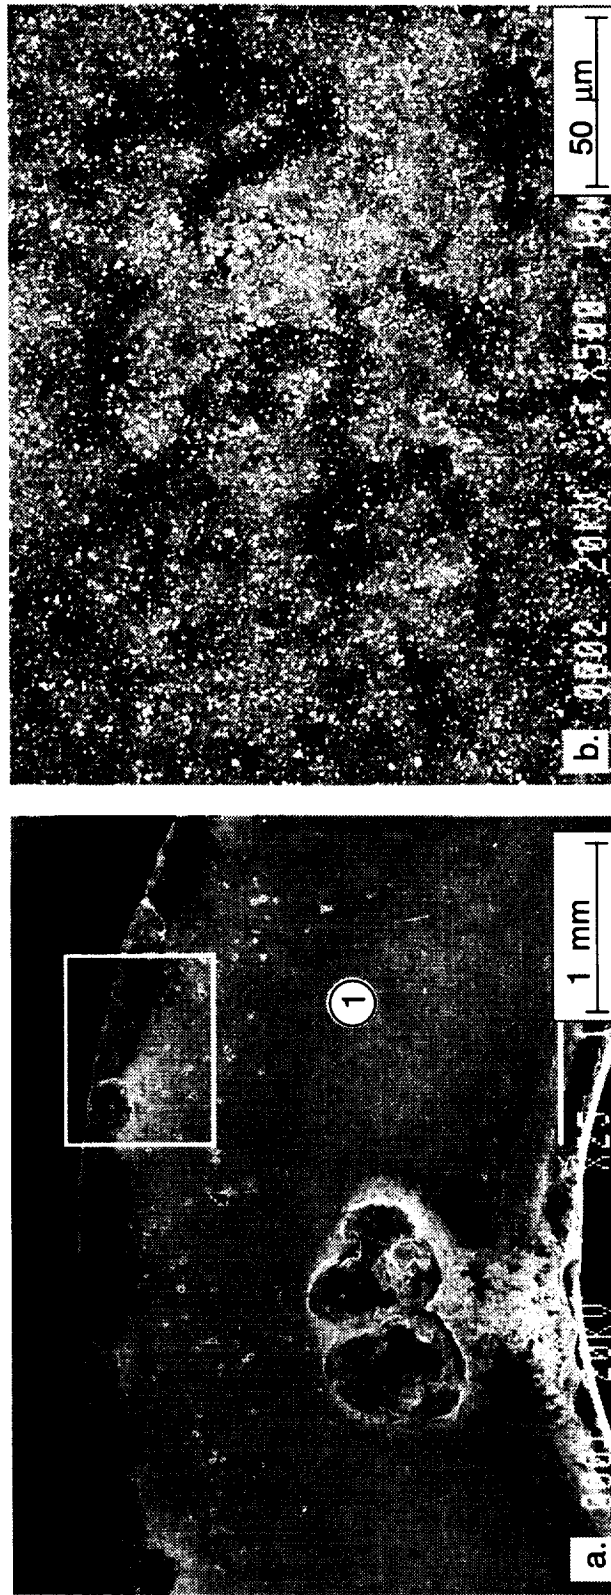
Fig. 55 SEM micrographs of the end of D218 shown in the box in Fig. 54a, (b) is a magnified view of the smooth scale near region indicated as (1). Box in (a) shows area of view shown in Fig. 56a.

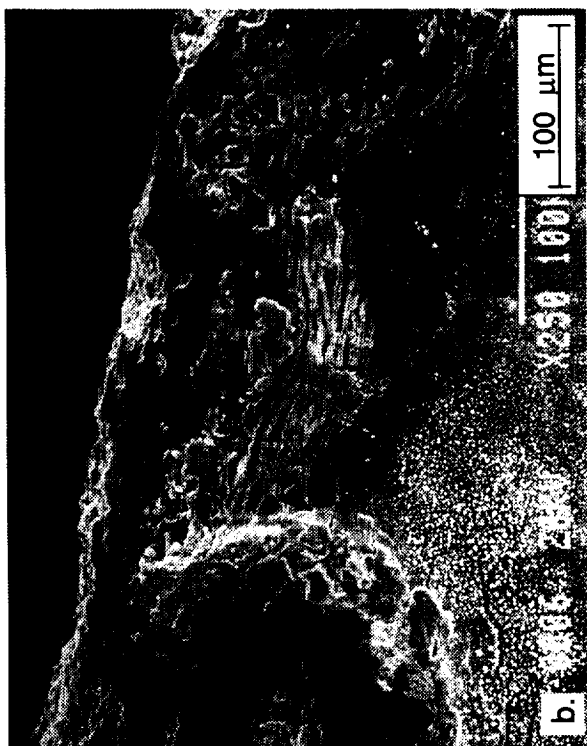
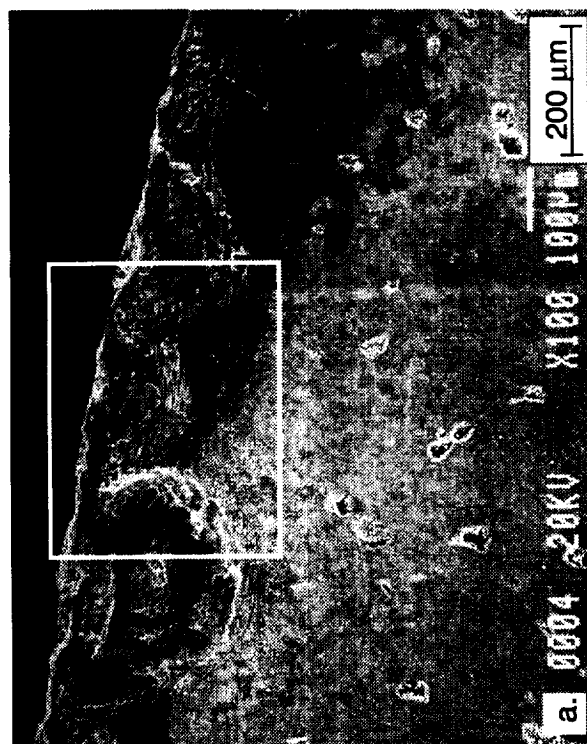
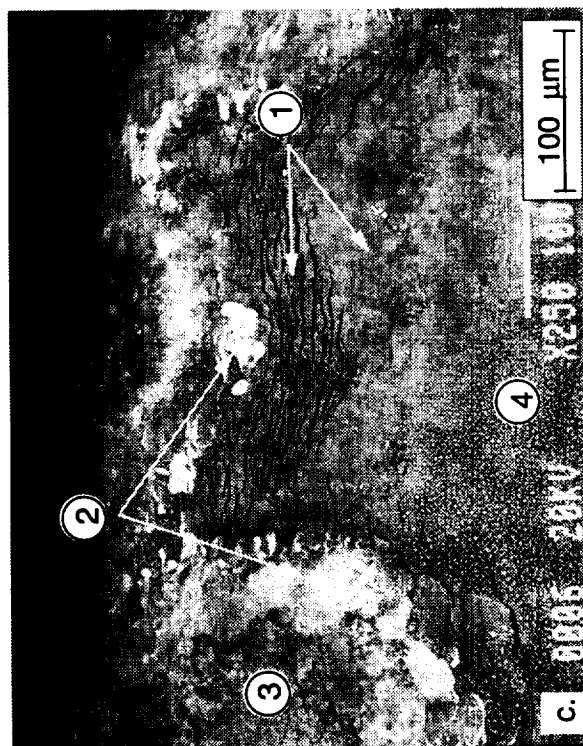
Fig. 56 SEM micrographs of the end of D218 shown in the box in Fig. 55a, (b) is a magnified view of (a) and (c) is a BSE image of (b).

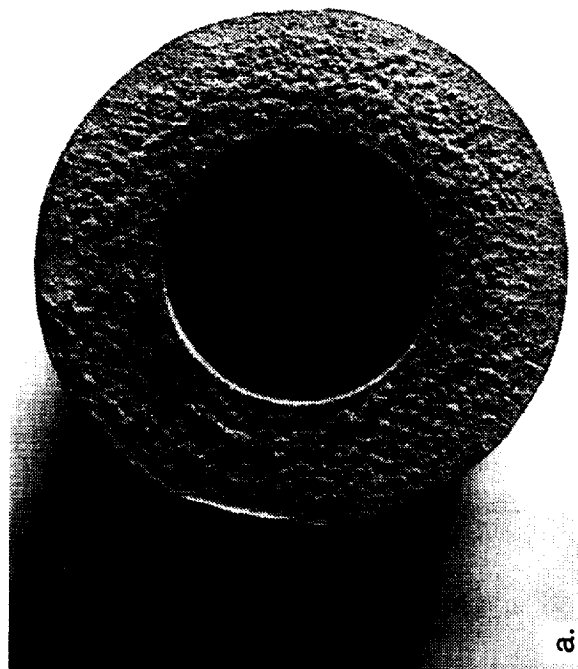
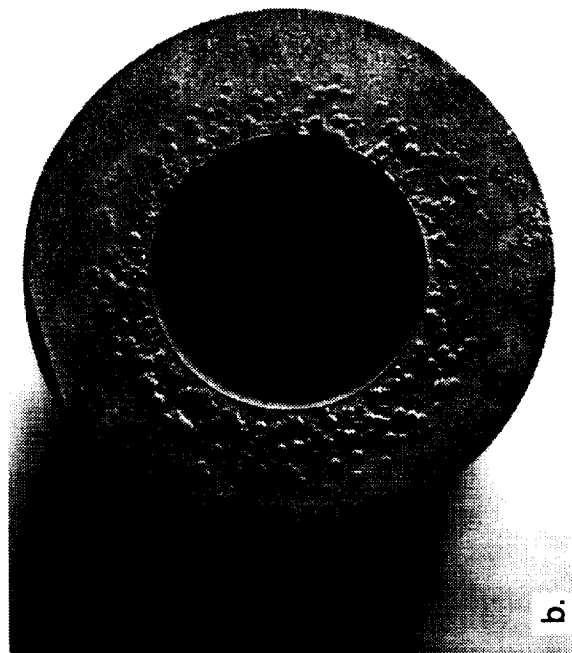
rougher than the other. Like AFN24, the corrosion morphology on each end was also different, apparent after only 50 hrs. The different corrosion morphology on the two ends after 100 hrs is shown in Fig 57. This morphology coarsened with time as shown after 200 and 300 hrs in Figs 58 and 59. It is interesting to note that although the mounds have grown slightly larger, there was no significant increase in the number of the mounds from 100 through 300 hrs. This behavior, that mounds which formed after short exposures only coarsened and coalesced with time without new mound formation, was typical on all the alloys. Nonuniform attack on the curved surface is shown after 200 hrs in Fig 58c,d. Although there is a noticeable increase in the size of the mounds and raised corrosion region after 300 hrs, again, there is no significant increase in the number of mounds or spread of the raised region on the curved surface between 200 and 300 hrs (compare Figs 58c,d and 59c,d). The somewhat parallel, raised lines in Fig 58c appear related to some dendritic structure. The lines are still visible after an additional 100 hrs (Fig 59c) indicating that, as stated earlier, the corrosion attack is by growth inward. Magnified views of the rough end of the sample (Fig 59a) are shown in Fig 60. The EDS spectra of the bumpy oxide in Fig 60c is Ca-rich, similar to that previously shown in Fig 46a. The smooth oxide in this figure is Al-rich with significant Ni and Ca similar to that in Fig 41c suggesting NiAl_2O_4 and/or mixtures with $\text{Ca}_3\text{Al}_2\text{O}_6$. The magnified view of the top of a corrosion mound in Fig 61a and the various contrasts in the BSE image of the same view given in (b) indicate the variety of oxides at the top and surrounding the mound. EDS analysis shows that the bright region (point 1) in Fig 61b is HF-rich, presumably HfO_2 . EDS analysis of the light gray oxide near the top of the figure (point 2) shows only the presence of Ni and O, indicating NiO. The EDS spectra of the area indicated as point 3 also indicates NiO, but with the presence of Mg and Ca. The EDS spectra of the darker oxide on top of the mound (point 4) is shown as Fig 61c and indicates a high level of Al but also substantial quantities of Ca, Ni and Ti. A lower magnification SEM view of the smoother end of the AFN20 sample (Fig 59b) is shown in Fig 62. The appearance of the scale morphology is similar to that previously observed on other alloys with much better hot corrosion behavior (Figs 49a, 52a). EDS analysis of the oxides and mounds were similar to that already described.

Fig. 57 Macrophotographs of AFN20 after 100 hrs showing different degree of attack on ends.

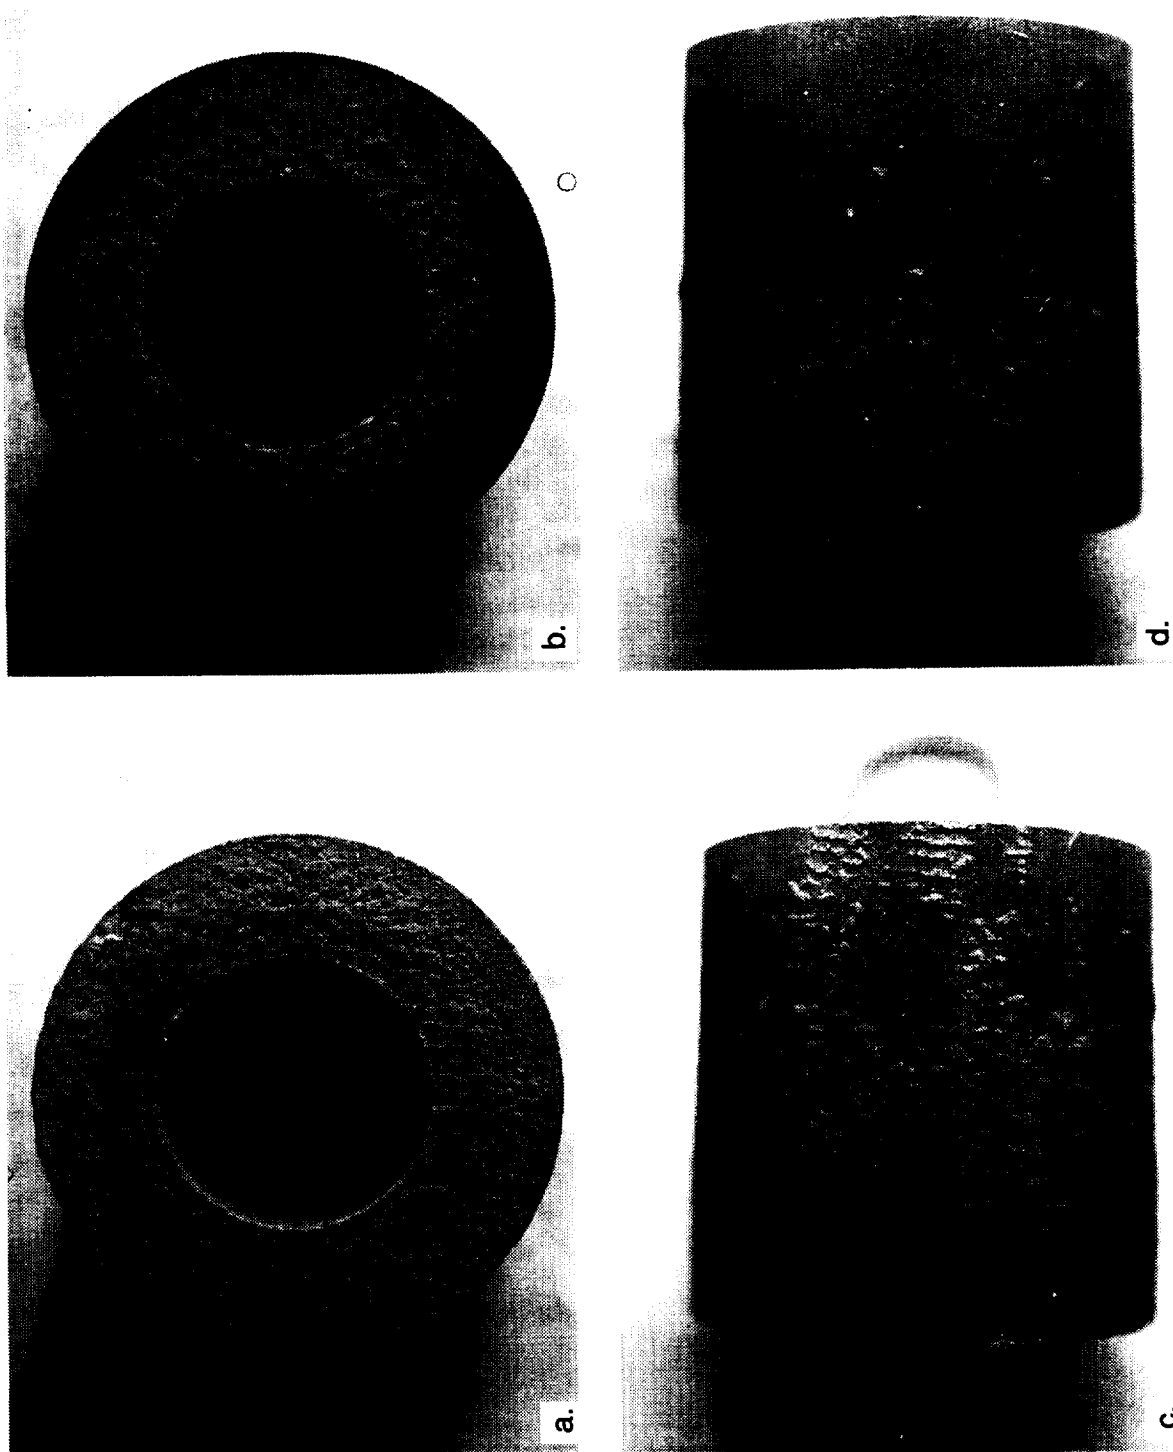
Fig. 58 Macrophotographs of AFN20 after 200 hrs showing coarsening of attack on ends (a,b) and accelerated attack on left half of curved surface (c,d).

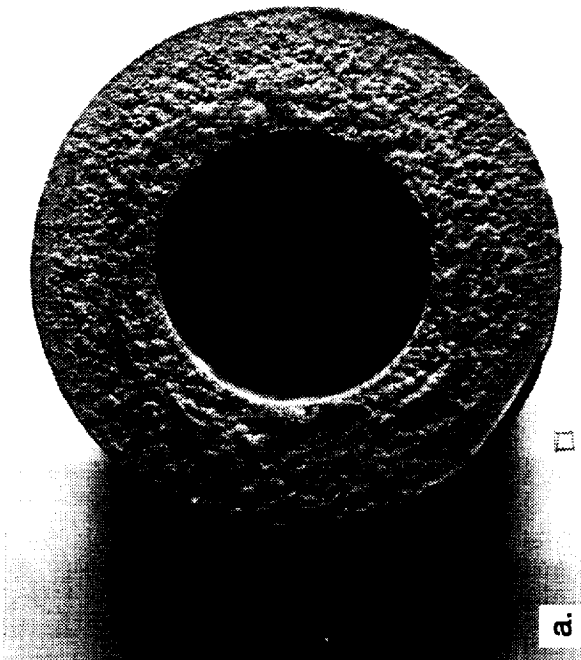
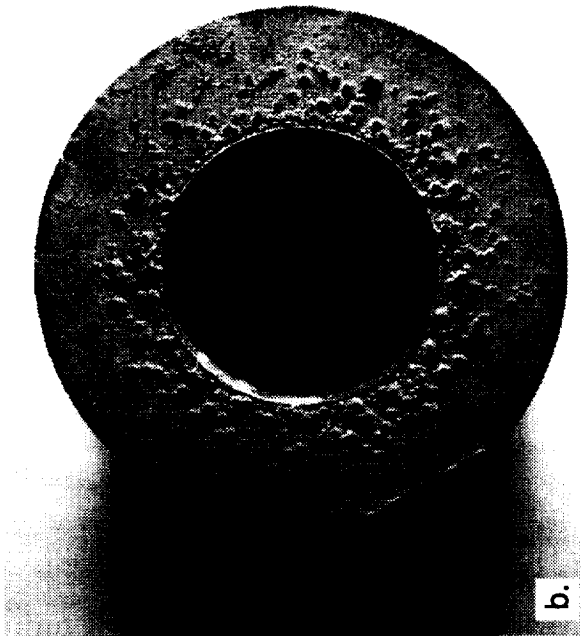
Fig. 59 Macrophotographs of AFN20 after 300 hrs showing coarsening of attack on ends (a,b) and curved surface (c,d).

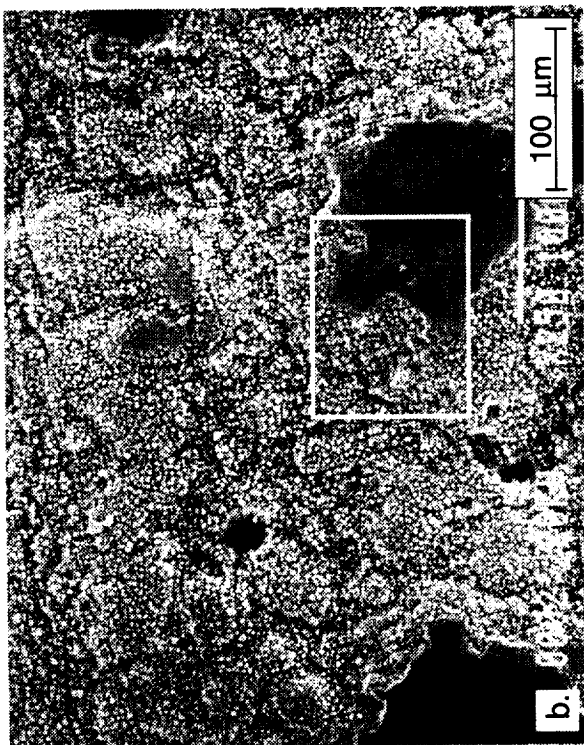
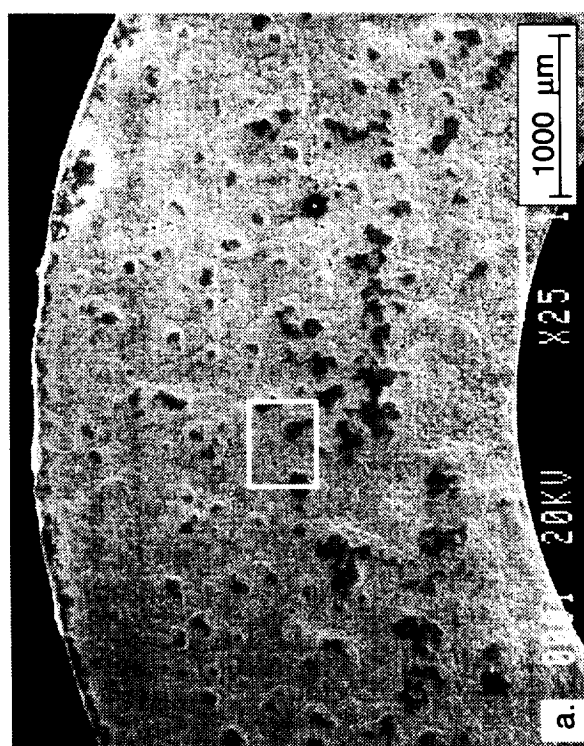
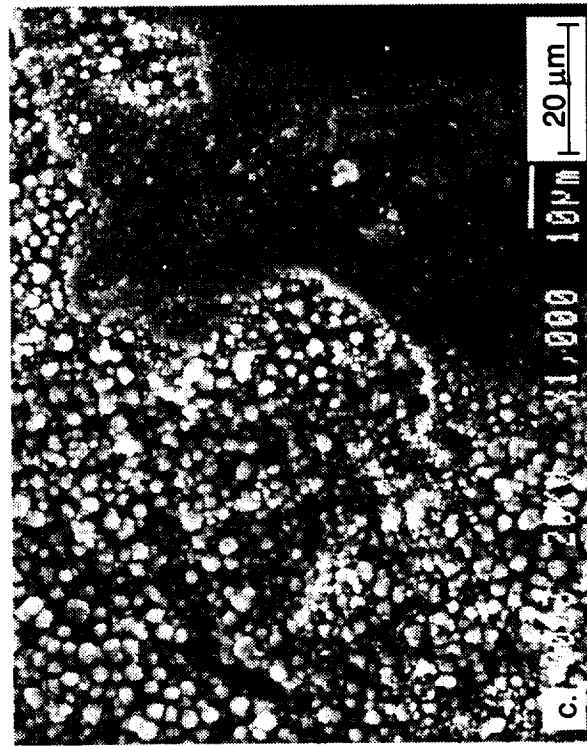
Fig. 60 SEM micrographs of the rough end of AFN20 after 300 cycles, (b) and (c) are magnified views of (a) and (b), respectively.

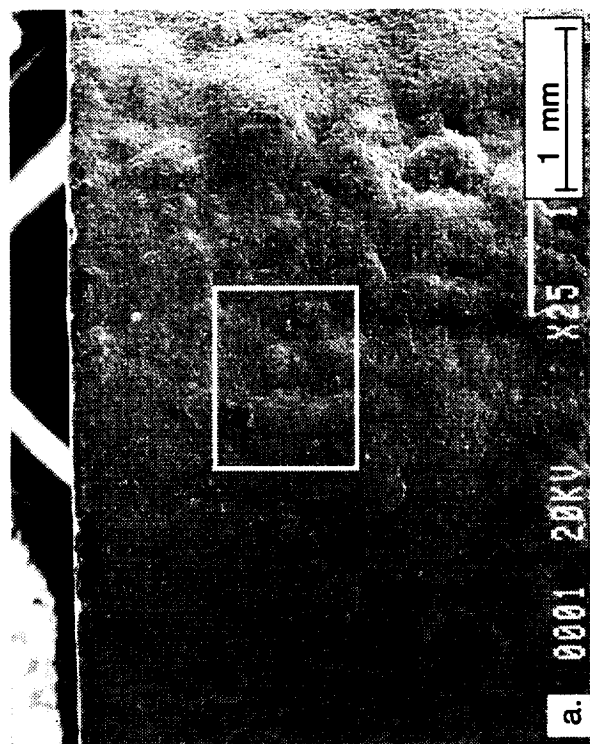
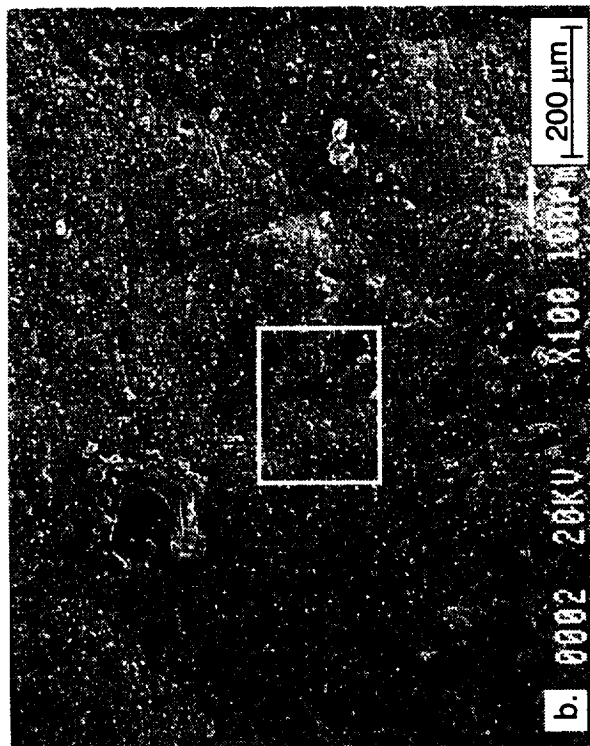
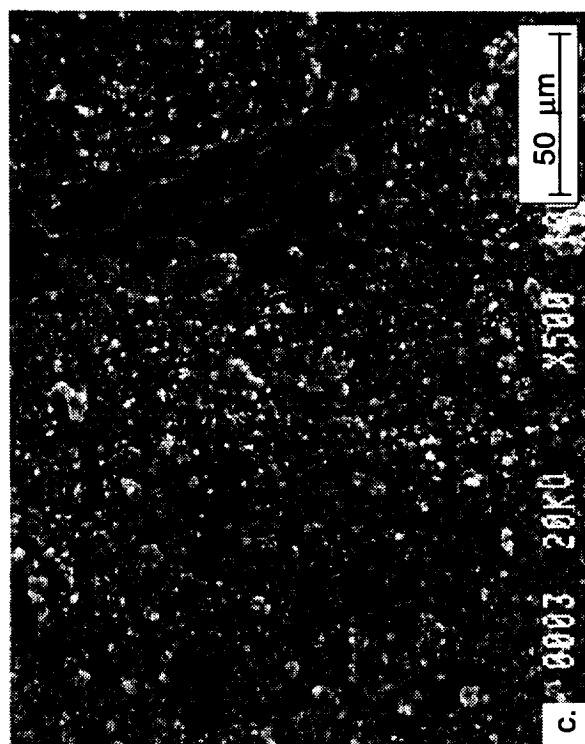
Fig. 63 SEM micrographs of the curved surface of AFN20 after 300 cycles. (b) is a magnified view of the box in (a), and (c) is a magnified view of the box in (b) (End in (a) is that to the left in Fig. 59c.)
